# Narberth to Canaston Bridge Engineering Feasibility Report

November 2018

## 1. Project Overview

## 2. Scheme Overview

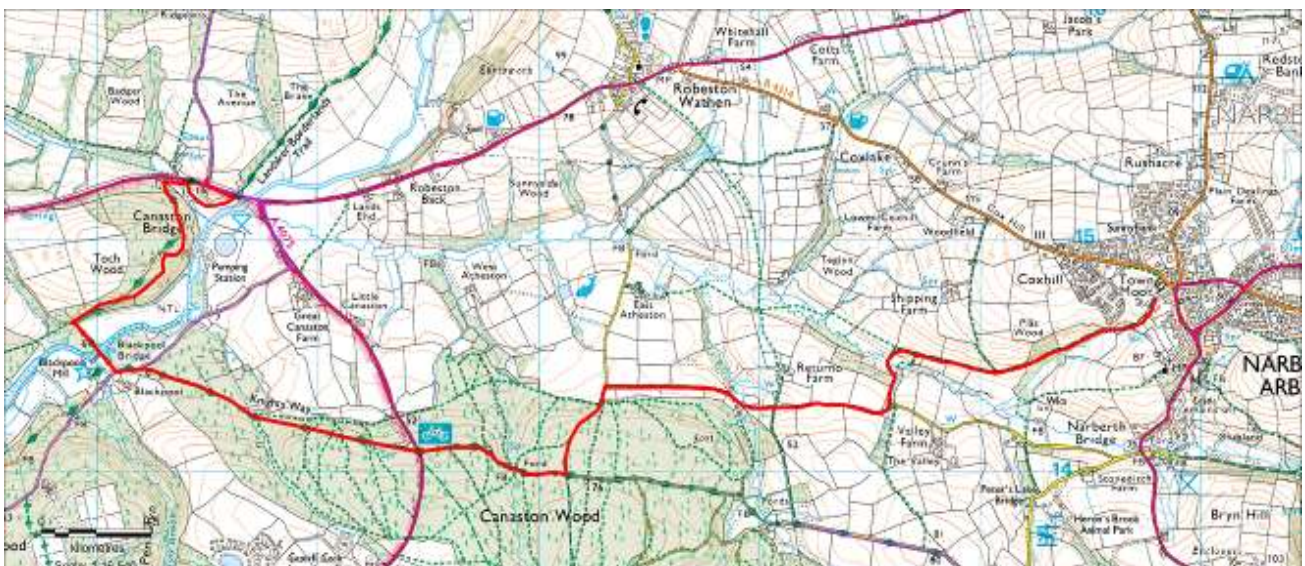
Map 1 Narberth to Canaston Bridge alignment

The proposed alignment follows existing routes for the most part following narrow country roads, bridleways and Public Rights of Way (PRoW). Overall, the existing paths are presently more suitable for MTB users although signposting is good. The path is currently used by cyclists, pedestrians (leisure walkers and dog walkers) and horse riders.

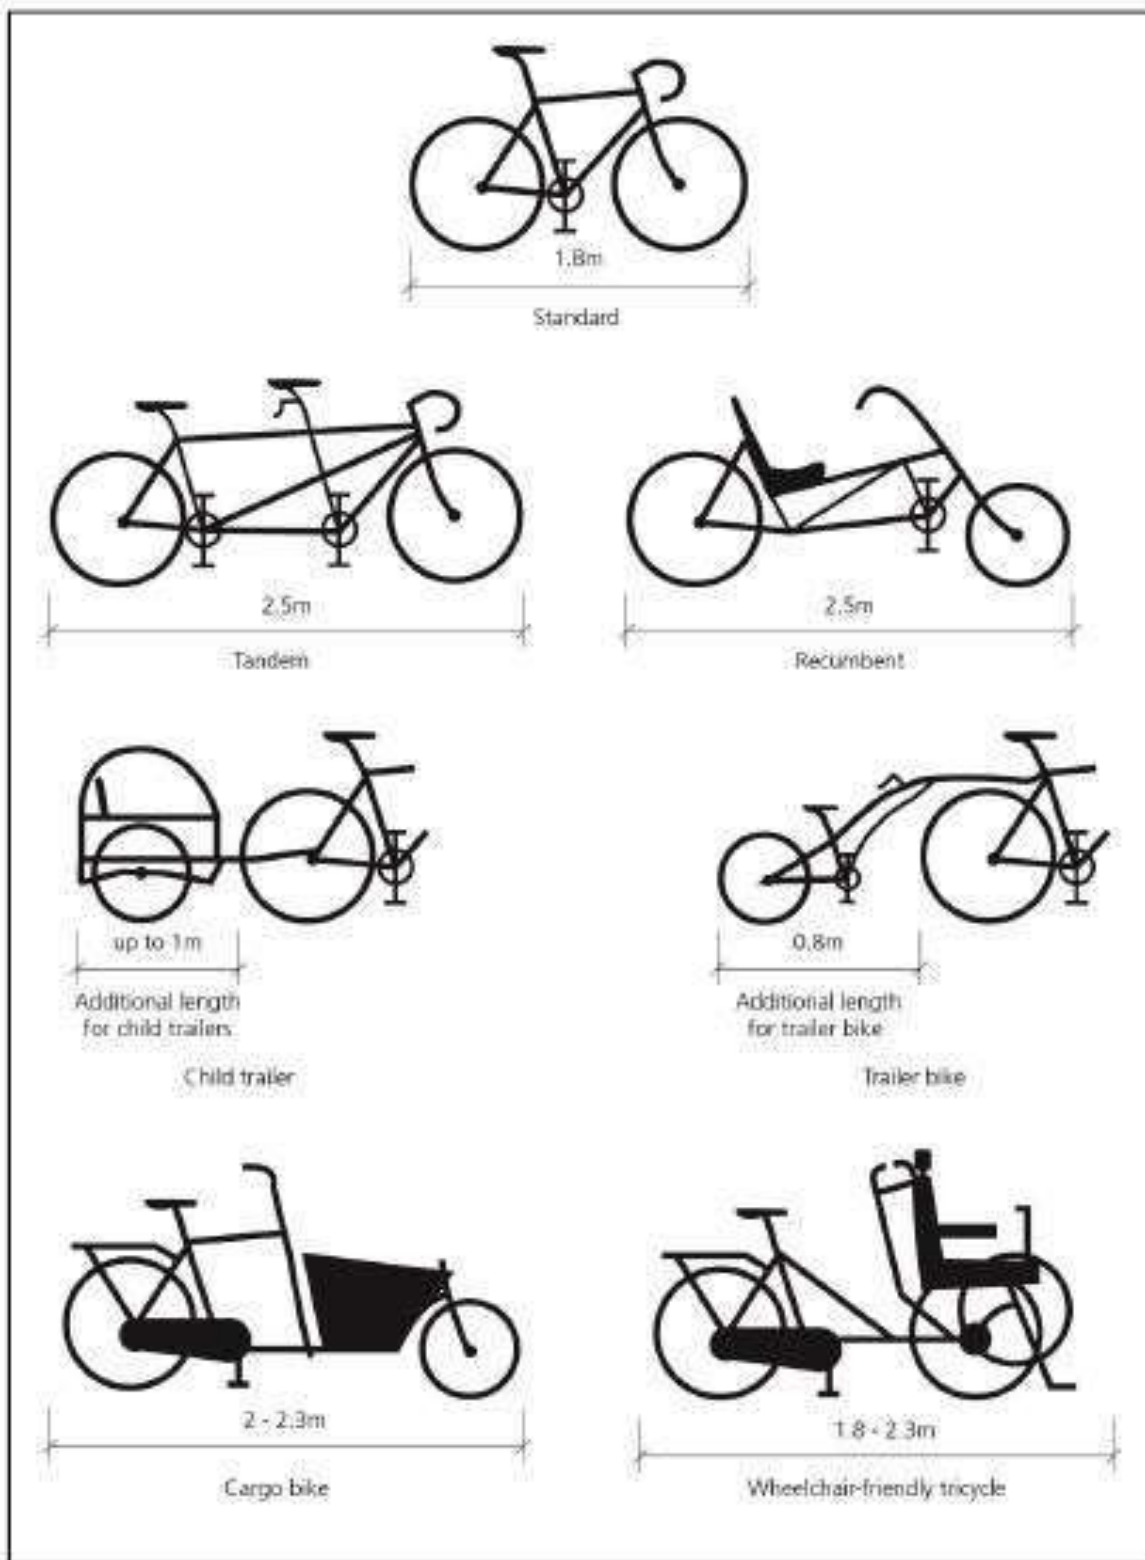
Figure 1.1 Highways England IAN 195 Bicycle dimensions

Designers should therefore recognise that the style of bicycles may change during the course of the work. Dimensions of Cycles and cyclists are detailed in section 4.11 of the ATA guidance and the diagram overleaf is taken from HE 195 and provides basic design sizes for a number of bicycle styles. Any control barriers installed along the route should reflect the dimensions indicated.

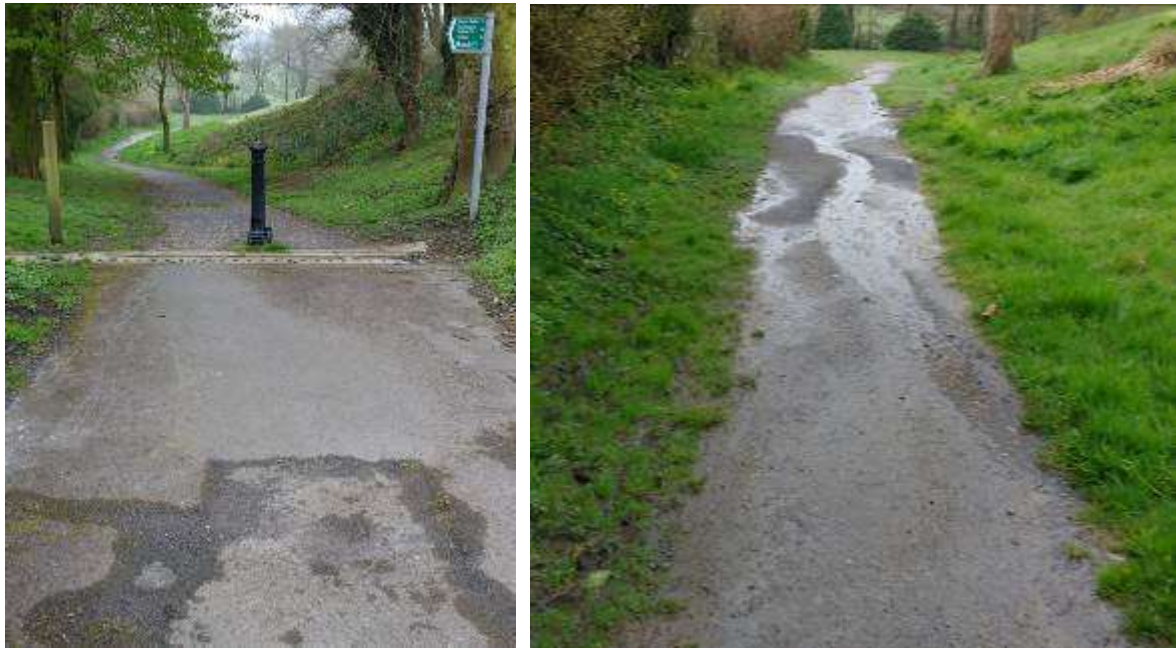
**Photo's 3.1 and 3.2 – Path beginning at Narberth.**

Drawing NC10662-10-A-01-01 indicates path widening and a filter drain (See detail SD/11 attached as Appendix A) to one side of the new path to hold the tip site run-off. Path widening continues to the bridge. There is sufficient width through this section to install a 2.5m wide path for pedestrians and cyclists with an adjacent 1.5m wide path for horse riders however, the pinch point at the bridge would make this a short section. Provision of a 3m wide path with a surface suitable for all users is considered to be preferable. A comparison of surface types is included in the following section. Best practice in relation to construction in close proximity to trees: BS 5837:2012 (Trees in relation to design, demolition and construction) may require the use of protective fencing to avoid incidental impacts on the trees located close to the path alignment. A small sub-pipe has been added to branch off from the existing drain to maintain ground/sub-surface water flows to the area of marshy grassland to the south-east of the path.

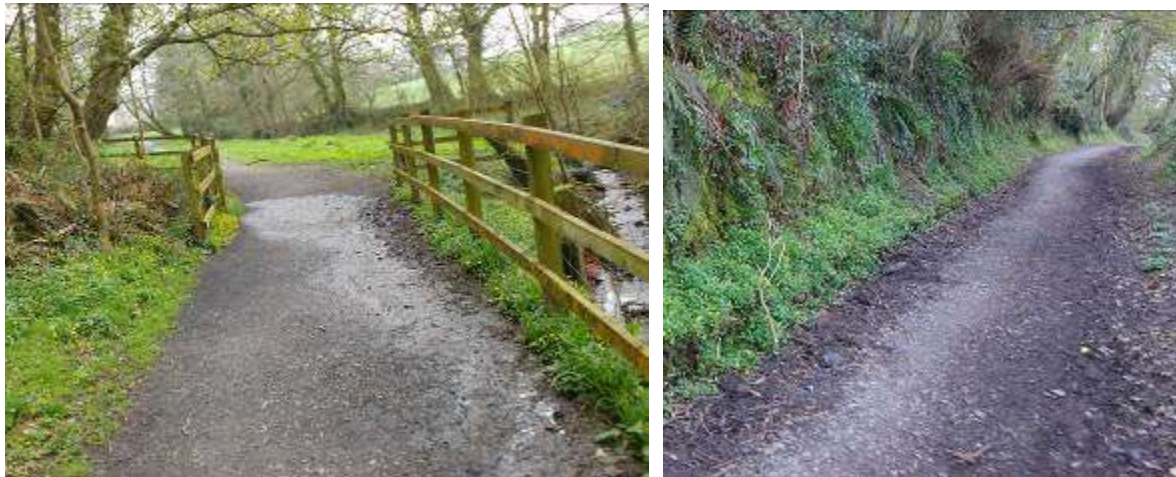
**Photo's 3.3 and 3.4 – Path over the bridge / culvert and the path beyond.**

After the bridge the path passes through woodland and narrows with a steep bank to one side a slope down on the other. The existing drainage requires improvement with a stream forming along the path after heavy rain. The topography leaves little scope for path widening from an existing width of approximately two metres.

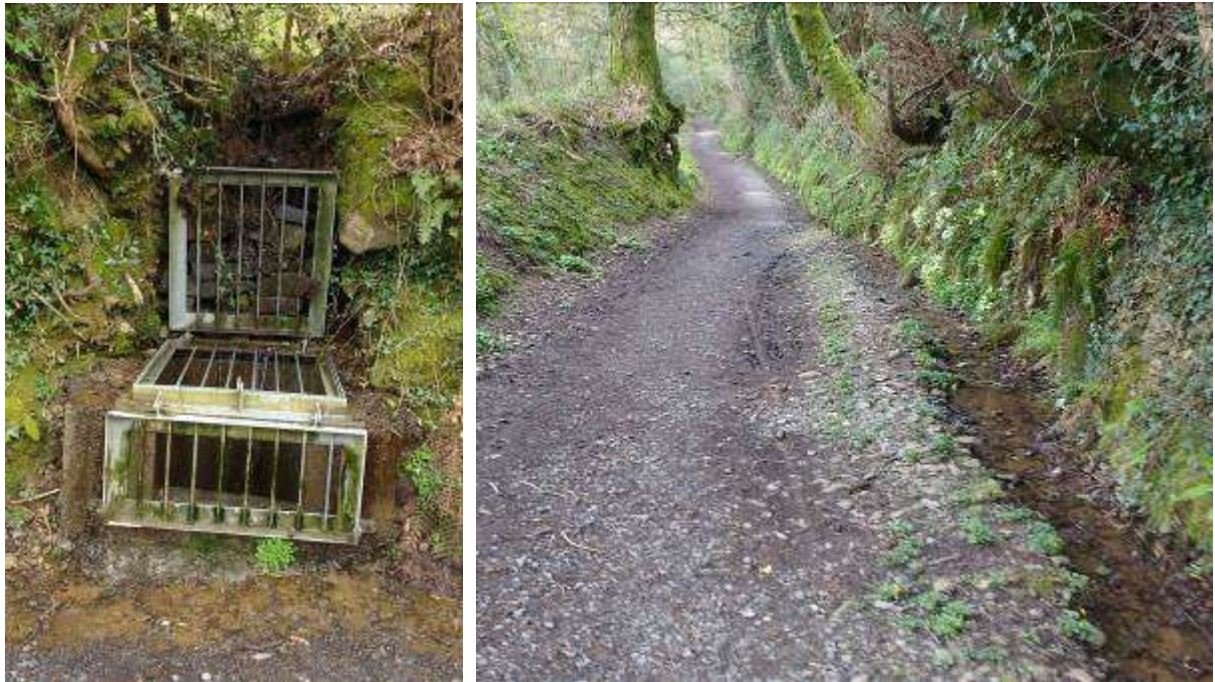
**Photo's 3.5 and 3.6 – Existing drainage and overflow.**

Further along the path more drainage issues are clear as water bypasses existing drainage channels to form a stream along one side of the path. The route at this point is cut into the hillside, restricting the available width which is restricted further at 'pinch points' in places where trees are present.

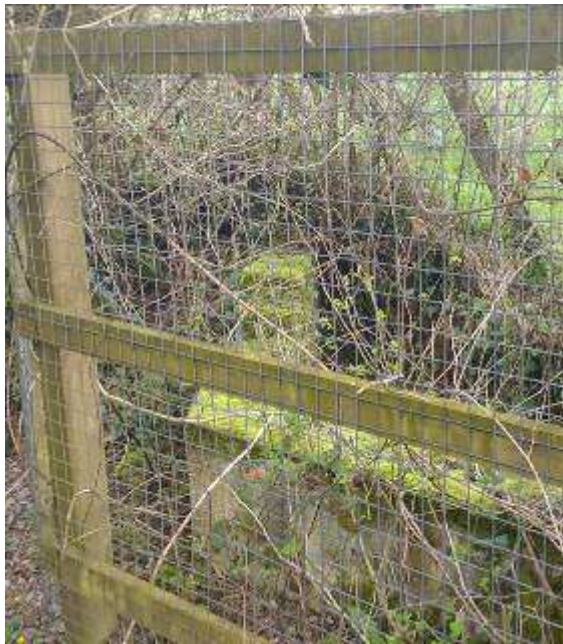
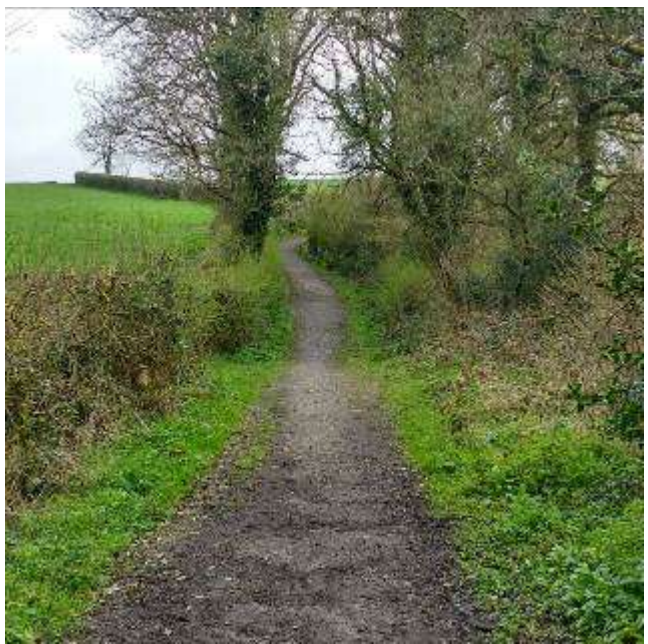
### Photo's 3.7 and 3.8 – Existing drainage and path

As the path follows field boundaries it turns sharply at a field corner to drop down a slope with restricted visibility. This route section is used by a local land owner to access fields with a vehicle and trailer. The recycled rubber material would be unsuitable therefore on this route section as vehicle wheels break up the material particularly on tight bends.

Drawing NC10662-10-A-01-01 shows proposed improvements along this section. Again, the available width will not allow a 2.5m path with a parallel 1.5m wide horse route. The proposed alternative is again to use the resin- bound rubber crumb with the addition of improved drainage. With path edge clearance and limited tree removal a useable path width of 2.5m is possible. Narrow stone filled gabion baskets dug into the path edge will replace the present stream. Due to the proximity of the rock wall or hedge this should not impact on useable path width. The presence of a mature Oak tree within the northern verge of this route section means that a no dig built technique will need to be employed in the vicinity of the tree.

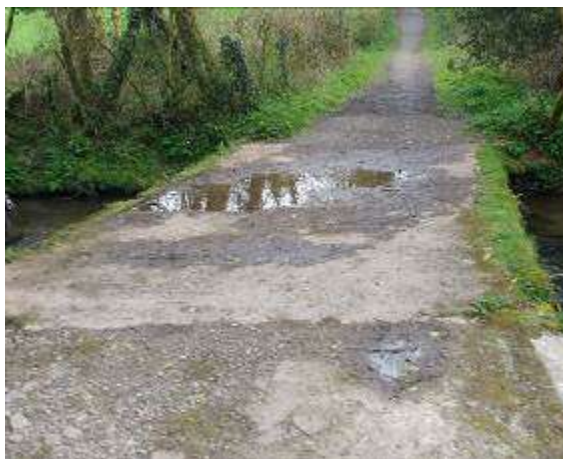
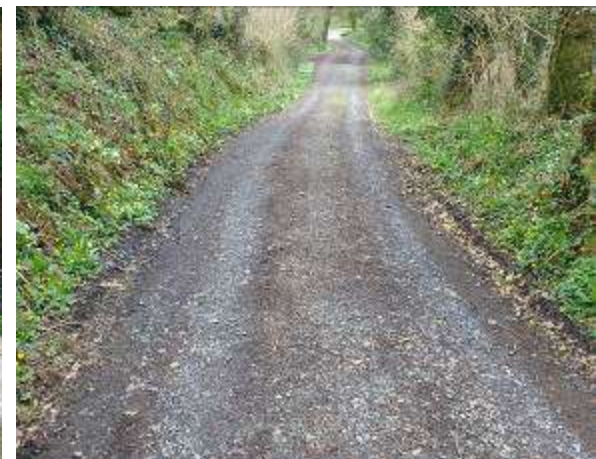
### Photo's 3.9 and 3.10 – Concrete Bridge and final section to Valley Road

Towards the end of this route section there is a concrete bridge (three metres wide) over a stream without parapets and with evidence of ponding. There is also a channel next to the bridge caused by flooding water. The path on either side of the bridge is tree lined but level with a width of approximately two metres.

The concrete bridge would benefit from a tarmac surface to prevent ponding and extending the tarmac out from the bridge to a point beyond where the channel has developed should result in flood water running over the path. The bridge also requires parapets, to be bolted onto the side of the existing concrete deck.

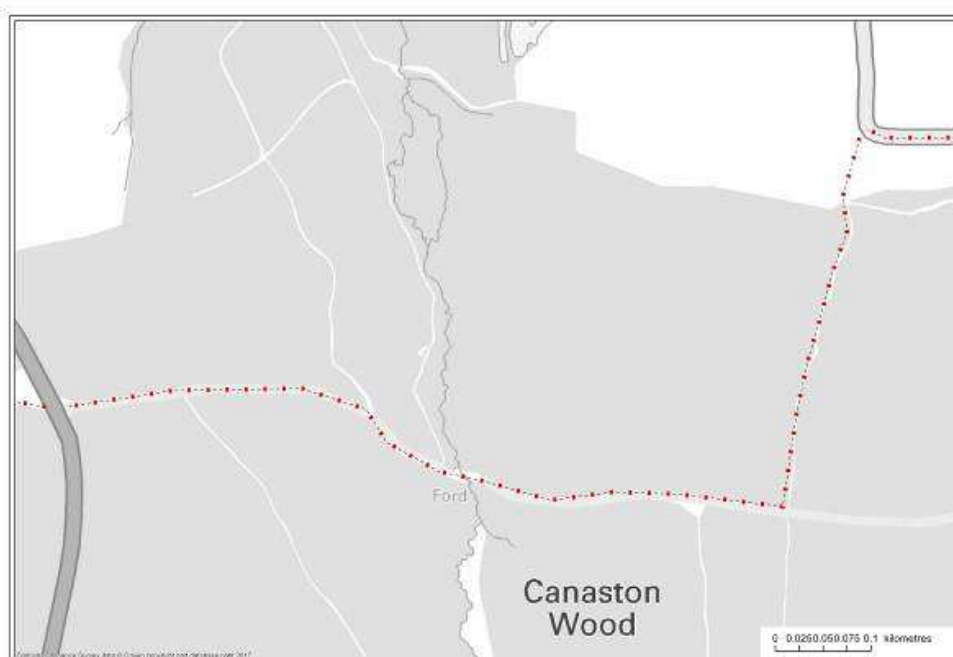
**Figure 3.3: PRow/Forestry Road to A4075**

The proposed route leaves Valley Road to head south along a narrow uphill PRow in a rock lined cutting to Canaston Wood. After 80 metres the land opens up and the path widens although the gradients remain steep. A significant present feature of the wood at this point is line of cleared trees cutting across the PRow indicating a high pressure gas main. A topographical survey has been carried out for this area in order that a path alignment with a reduced gradient can be determined. The long and cross sections for the path in this area are shown in drawing NC10662-10-A-01-06.

The gradient reduces as the PRow re-enters the wooded area with more space to the sides of the path for widening. After approximately 250 metres the path joins a well constructed rolled stone forestry road (designated County road) heading gradually down towards the A4075. Part way down the forestry road a path follows a separate cutting down to the A4075. The surface on this alignment is poor and users are required to cross a ford at the lowest point. Improving this alignment would be expensive and is un-necessary given the presence of a good quality parallel route. The forest road path has a T-junction onto the A4075 with a separate uncontrolled crossing point for pedestrians and cyclists linking into a new path in the verge on the opposite side of the A4075 Figure 3.3 indicates the alignment).

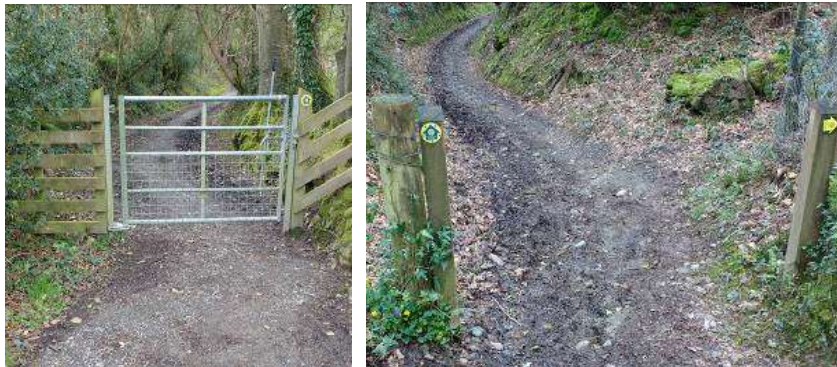
**Photo's 3.13 and 3.14 – PRow from Valley Road through Canaston Wood.**

The initial route section from Valley Road can be re-resurfaced but only widened where the rock walls of the cutting allow. The cutting also severely limits any opportunity to alter the path gradient along this initial 80 metre section. Drawings NC10662-10-A-01-03A and NC10662-10-A-01-03B indicates the revised path alignment through the following section where the more open land has allowed a reduction in the gradient from 1:8 to 1:11 (with rest areas) and the provision of a 3 metre wide path. The cross sections indicate the extent of the earthworks required to provide a path with a reduced gradient. They also show a path level above that of the high pressure gas main. The restrictions on working in the vicinity of high pressure gas mains and the fill required at this point mean that the path will have to bridge the gas main. This could be achieved by constructing a simple structure made up of Gabion baskets supporting a short steel or concrete deck over which the path could be built. The presence of mature trees and their root systems at the northern end of the re-graded path introduces an ecological constraint for which further measures would be required to prevent damage (no dig build for example). A boardwalk could also be considered for this relatively short route section although this may increase costs and would introduce a potentially obtrusive structure into this rural environment.

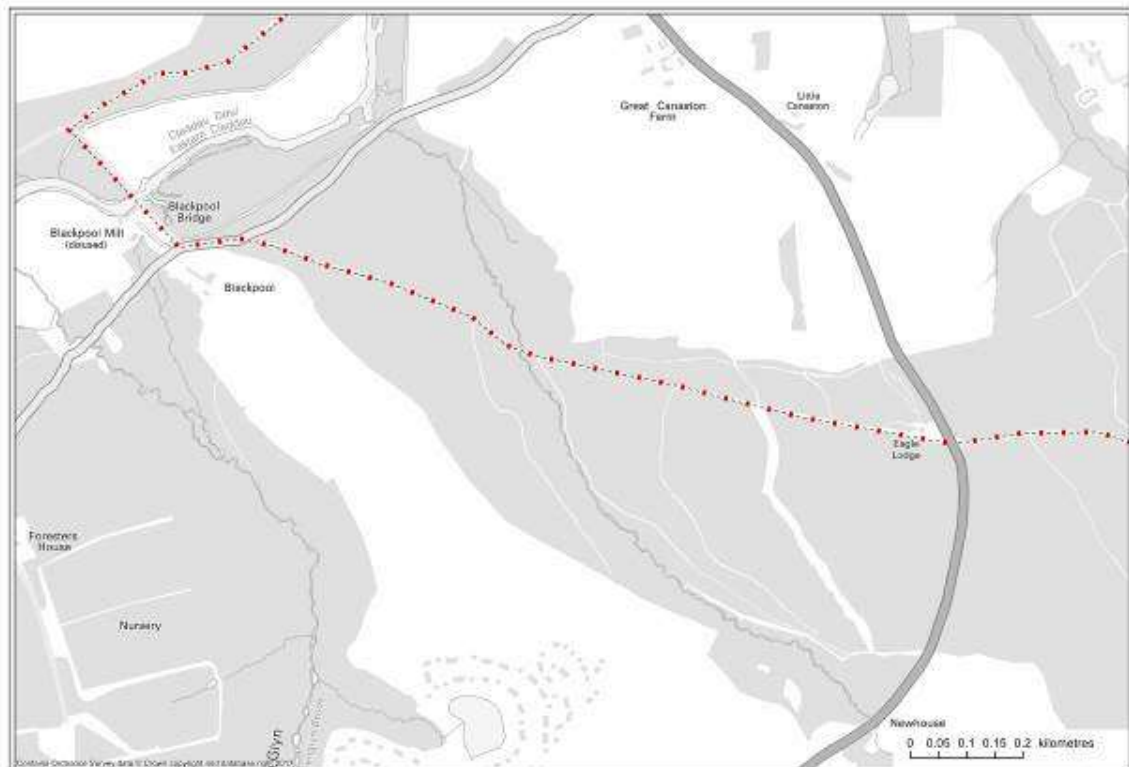
**Figure 3.4: A4075 crossing to Blackpool Mill Bridge**

The existing rolled stone path from the A4075 to just short of Blackpool Mill is approximately 2.8 metres wide but would be 3 metres if edged. The existing surface would provide an ideal base for a fully sealed surface but minor improvements to the existing would reduce costs and give an adequate ride.

The path crosses one bridge on the way to Blackpool Mill. This 6.8 metre wide structure has newly restored parapets and a 3.6 metre wide concrete deck. The parapets are only 0.9 metres high and therefore not suitable for a cycle path (Ideally parapets should be a minimum of 1.4 metres high). However, the 6.8 metre width between parapets means that cycles can be directed to the concrete slab in the bridge centre, well away from the parapet. The provision of grass verges between parapets and the concrete slab would keep cyclists to the middle of the bridge.

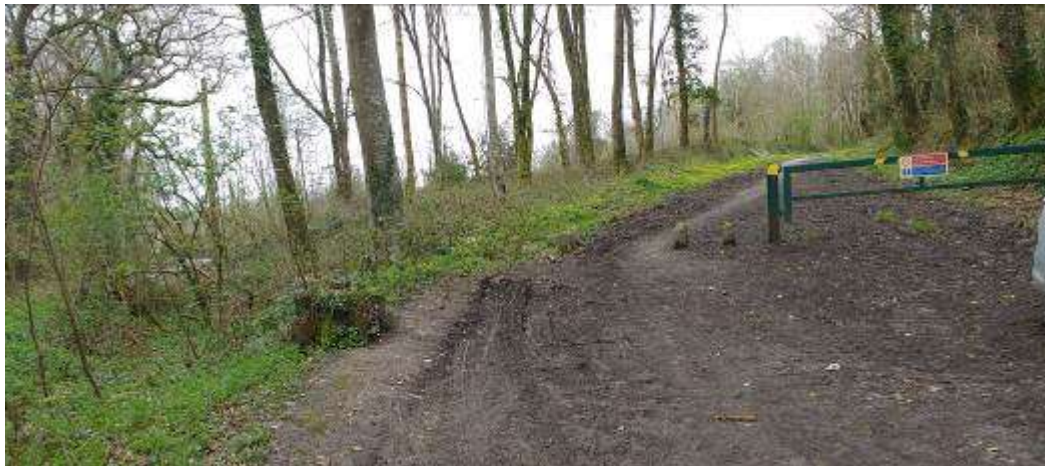
Photo 3.22- 'Knight's Way' entrance with Kent carriage access.

On the approach to Blackpool Mill the path joins a narrow lane giving access to a small car park and Blackpool Mill itself. Where the path joins the road a gate and Kent carriage crossing are provided. Parking occurs at this location, often blocking the route for cycles.

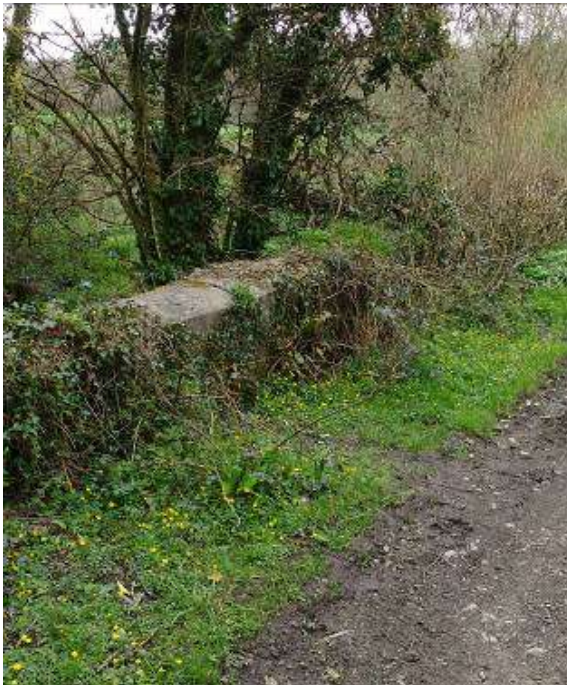
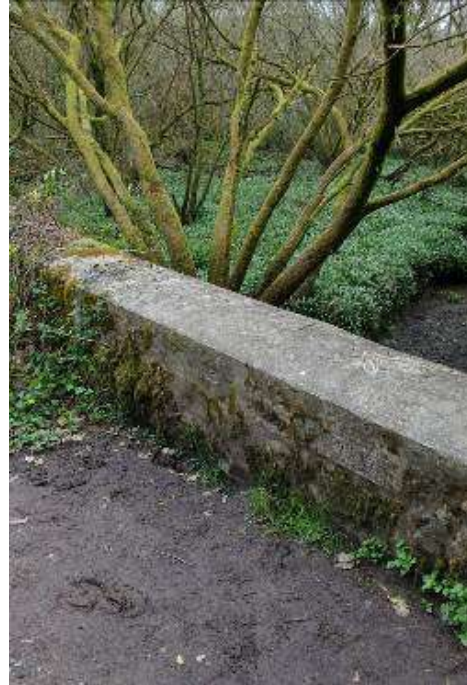
Photo's 3.26 and 3.27 – Low bridge parapets west of Blackpool Bridge

This path section also includes two bridges of similar widths and lengths. Both bridges also have similar very low parapets (60cm) but sufficient width to guide cycles through the middle (5.3m) away from parapets, alternatively it may be possible to add railings (should the structures not be listed).

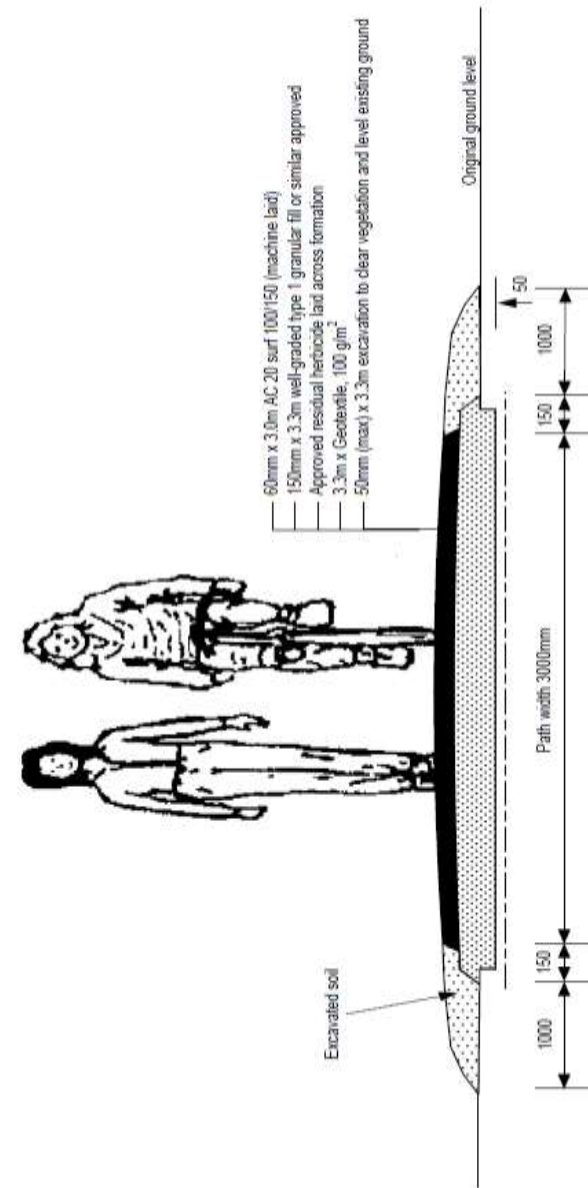
**Standard DBM path cross section**

1. Centre line of path is as indicated on General Arrangement Plans.
2. Soft and woody vegetation to be cleared 2 metres from edges of path and 3.5 m above path surface. No works to specimen trees other than as directed by approved arboriculturalist.
3. All cleared vegetation to be chipped and spread locally on site. Larger timber to be supplied to land owner if required or stacked into habitat piles on site.
4. Excavation to level existing track to be kept to a minimum. Arisings to be temporarily stored for subsequent use as support to edges of path. Excess spoil to be spread locally on site.
5. Finished surface to be laid to 2.5 % cross fall/camber, to be free draining, free of undulations and / or steps and should not pond or hold water.
6. This drawing to be read in conjunction with all other drawings.
7. Asphalt to BS EN 13106-1

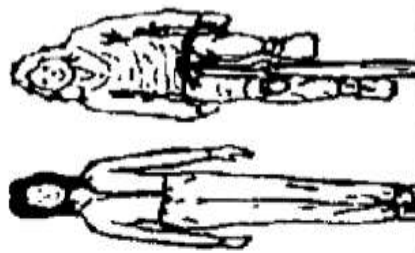
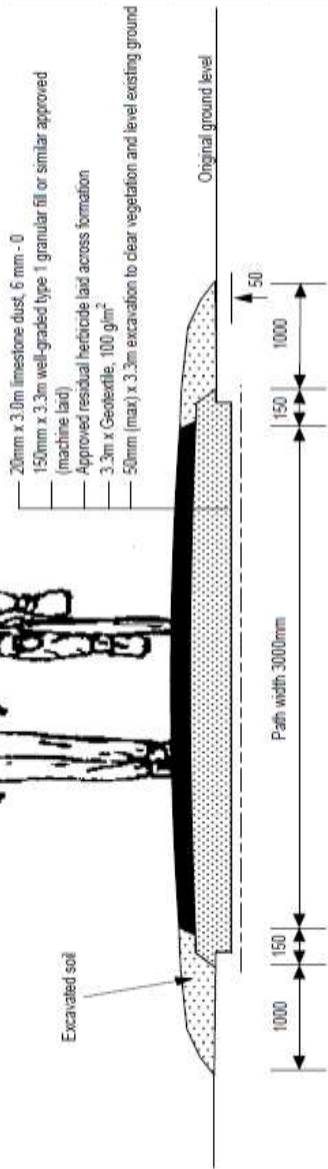
**Standard limestone dust path cross section**

1. Centre line of path is as indicated on General Arrangement Plans.
2. Soft and woody vegetation to be cleared 2 metres from edges of path and 3.5 m above path surface. No works to specimen trees other than as directed by approved arboriculturalist.
3. All cleared vegetation to be chipped and spread out locally on site. Larger timber to be supplied to land owner, if required, or stacked into habitat piles on site.
4. Excavation to level existing track to be kept to a minimum. Arisings to be temporarily stored for subsequent use as support to edges of path. Excess spoil to be spread locally on site.
5. Finished surface to be laid to 2.5 % cross fall/camber, to be free draining, free of undulations and / or steps and should not pond or hold water.
6. This drawing to be read in conjunction with all other drawings.
